### INTRODUCTION

Sear Brown performed a site review and survey of the Capitol grounds to determine the condition of site features such as sidewalks, stairways, curb and gutters, handicap ramps, parking lots, and utilities. These items were photographed and logged and are included in the Exterior Site Survey found in the Appendices. Sear Brown then analyzed the capacities and conditions of the existing utilities to determine whether or not they complied with current standards and met the operational needs of the facilities they serviced. Recommendations were made for improvements to the site features and utility systems for the Capitol site.

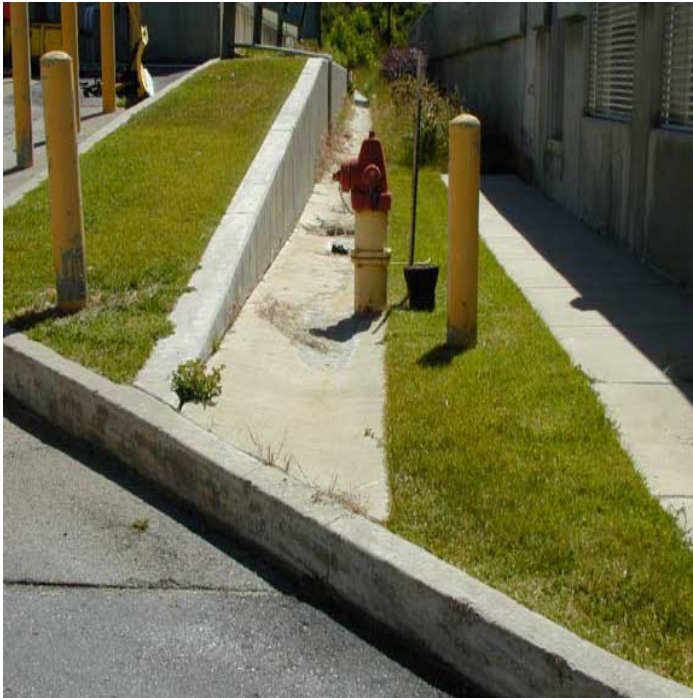
During a site visit, the fire hydrant closest to the Archives building was photographed. Access to the hydrant is limited by the narrow driveway between the Archives building and the Greenhouse facilities. See the photos below.

*LOCATION OF HYDRANT NEAR ARCHIVES*

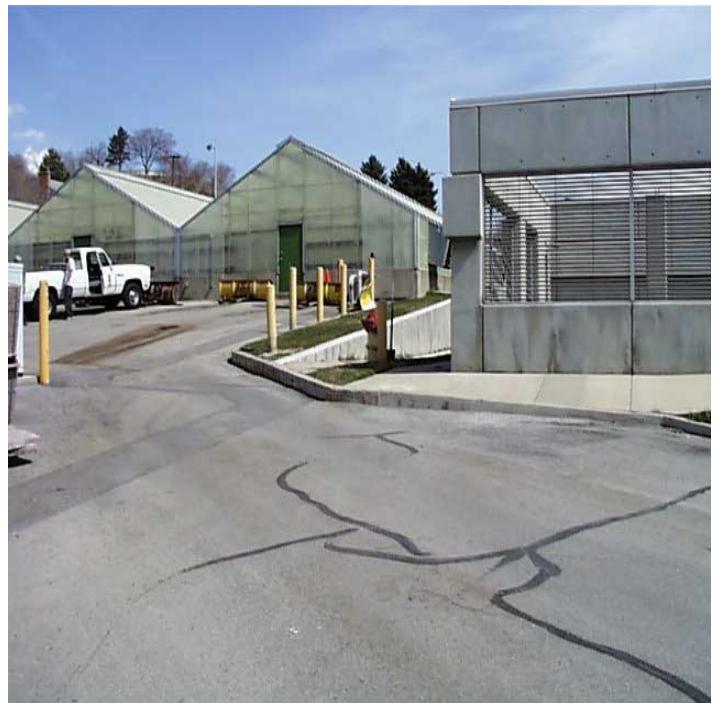
*ACCESS TO HYDRANT NEAR ARCHIVES*

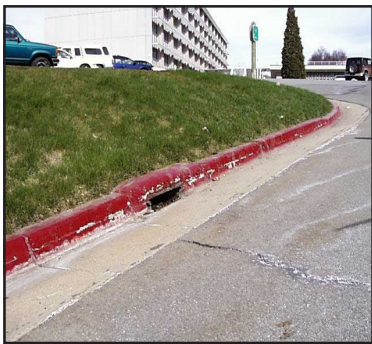
OUTFALL POINT AT ENTRANCE TO  
PARKING AREA FROM COLUMBUS ST.

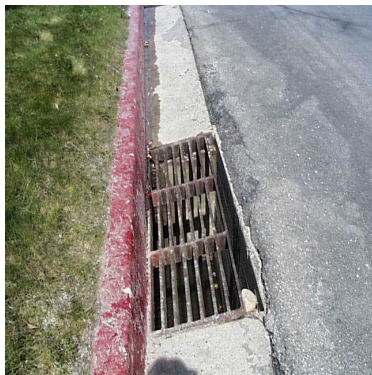
CATCH BASIN ON EAST CAPITOL NEAR  
ENTRANCE NOT SAFE FOR BICYCLES

Several problems were noted with the existing storm drain system. As shown in the photo to the left, the grate on the East Capitol catch basin is not bicycle safe, which makes it a potential safety hazard. Additionally, it is the only catch basin for the large parking lots on the east side of the Capitol site. A second grate is located around the corner near the parking entrance as shown on the following page; however, it is plugged with debris. Flow from these catch basins discharges directly into City Creek without detention or water quality

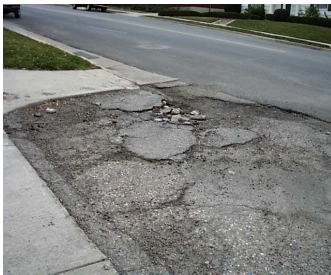
The high percentage of pavement and roof-covered areas within the Capitol site generates large volume, high velocity runoff. Most of this flow travels by sheet flow or curb and gutter flow capable of erosion and scour. The predictable results are visible in the photos below. Eroded asphalt and damaged curbs are common in several locations. Such areas tend to develop more problems as time progresses.

*ASPHALT DETERIORATION AND APPARENT PONDING LOCATION AT ENTRANCE TO SW PARKING AREA*

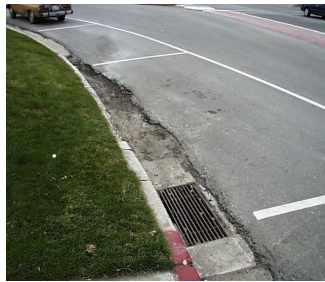
*CURB AND GUTTER DAMAGE AND ASPHALT DETERIORATION ALONG 300 NORTH ACROSS FROM COUNCIL HALL*

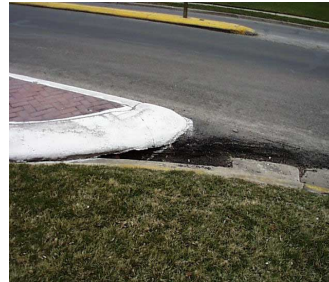
*ASPHALT SCOUR ALONG 300 NORTH WEST OF STATE STREET*

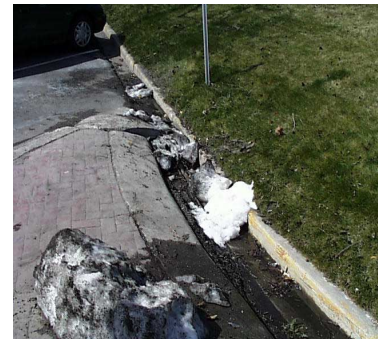
*CATCH BASIN ONE EAST ENTRANCE DRIVEWAY TO CAPITOL PLUGGED WITH DEBRIS*

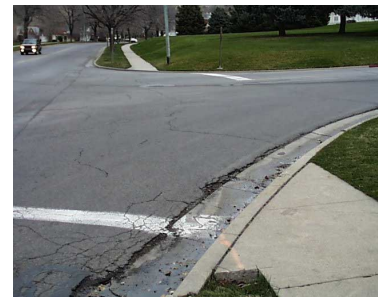
*ASPHALT CRACKING AND DETERIORATION AT WEST PARKING ENTRANCE ON COLUMBUS STREET*

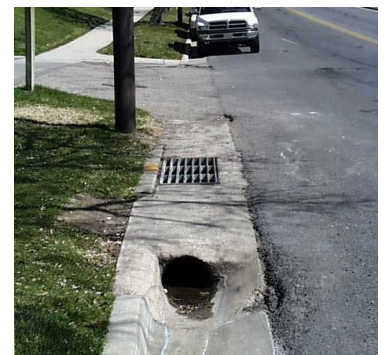
As seen in the photo at the right, storm drainage is collected into a catch basin, but then returned to curb and gutter flow. This configuration is unusual, as the flow collected by the catch basin would normally remain in a pipe and flow to the next downstream catch basin.

*CATCH BASIN FLOW TO CURB AND GUTTER FLOW ALONG 300 NORTH*

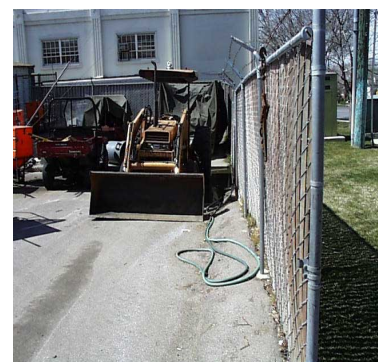
Standing water ponds in an equipment storage area between the Archives Building near the Greenhouse. The photo at the right shows a low area curbed in by the fence. There was no visible drain or catch basin for the area.

*LOW AREA WITHOUT DRAINAGE ADJACENT TO ARCHIVES BUILDING*

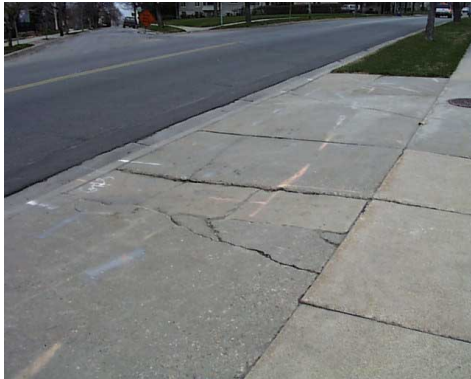
*WEST ENTRANCE SIDEWALK ALONG COLUMBUS STREET.*

The majority of the existing pedestrian access system is in good condition. However, several areas show signs of deterioration and cracking. As shown in the photos above, the sidewalk along Columbus Street is cracked at both the west entrance and at Apricot Street.

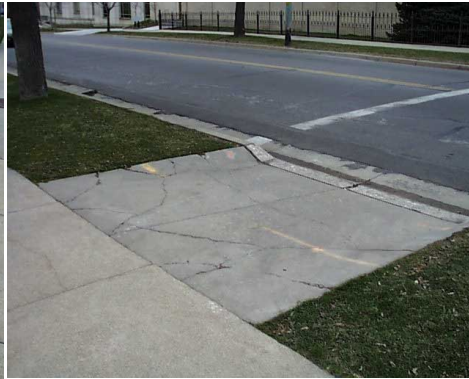
*HANDICAP RAMPS SIDEWALK AT COLUMBUS STREET AND APRICOT STREET.*

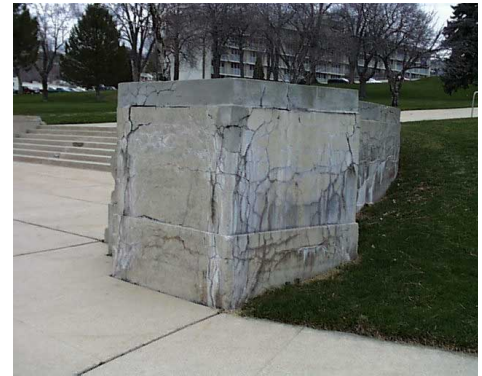
*STAIRWAY FEATURE AT WEST ENTRANCE ALONG COLUMBUS STREET.*

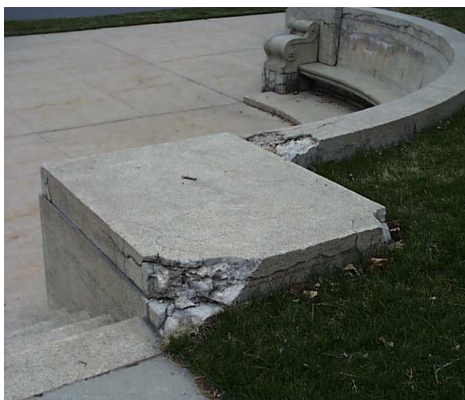
The stairway features at the west entrance to the Capitol are in poor condition as shown in the photos below. The stairway features on the south side of the Capitol are also showing signs of deterioration. The concrete steps and surrounding ledges are spalling and deteriorating. The top of the ledge has also chipped away. The stairs to the Mormon Battalion are in poor condition and in need of repair. The stairs are covered with loose concrete chips and rocks, creating a safety hazard for visitors.

*STAIRWAY FEATURE AT WEST ENTRANCE ALONG COLUMBUS STREET.*

The existing system of sidewalks and stairways is in relatively good shape. However, several stairways and stairway elements are in need of repair in order to maintain a safe and functional environment. Handicap ramps should be installed to allow full access to the site, particularly on the west and south side entrances to the Capitol. The plaza and stairs on the south side that lead to the front of the Capitol are in rough condition and should be repaired/restored. The recommendation is to repair the sidewalks and stairway elements showing deterioration which impairs the safety and function of the facility. Also, handicap accesses to the Capitol building and other historical features should be provided to comply with current ADA requirements.

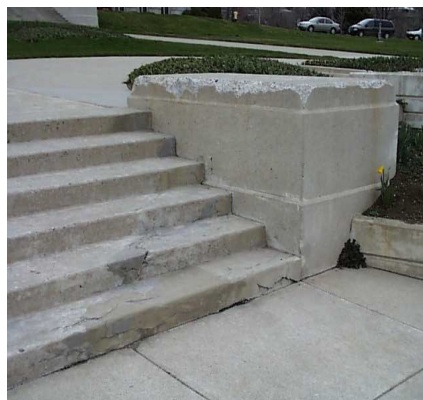
*STAIRS ON SOUTH SIDE NEAR FLOWER GARDENS.*

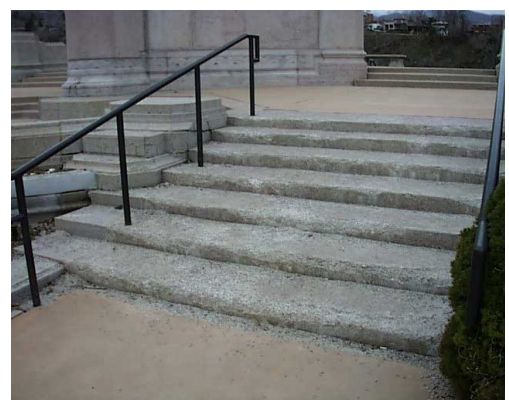
*STAIRS ON SOUTH SIDE NEAR THE MORMON BATTALION.*

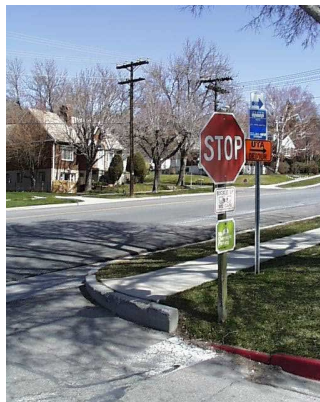
The sidewalks along the northern boundary of the Capitol grounds do not have handicap ramps, interrupting the travel path around the Capitol site. The photos below demonstrate two locations without ramps.

*NO HANDICAP RAMP, 500 NORTH NEAR*

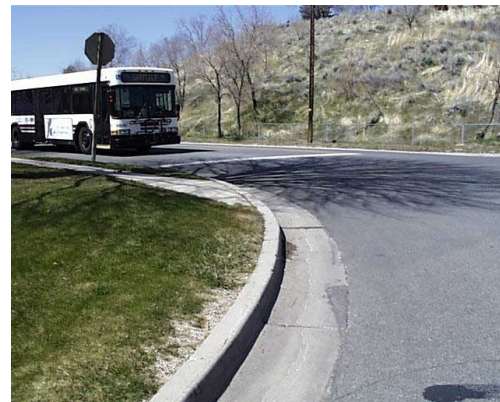
*NO HANDICAP RAMP AT 500 NORTH NEAR EAST CAPITOL*

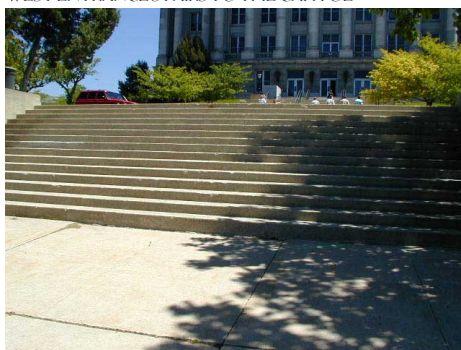
The main entrances and stairs to the Capitol building from the west and south side are also not ADA accessible.

*WEST ENTRANCE STAIRS TO THE CAPITOL*

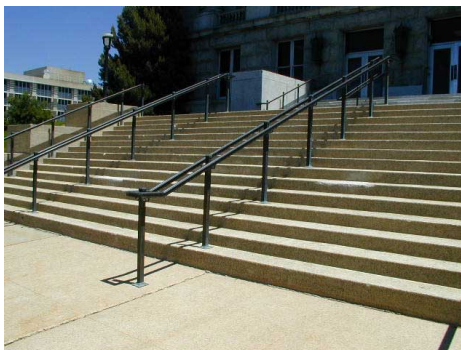
*SOUTH ENTRANCE STAIRS TO THE CAPITOL*
